# UNUSUAL LOCATION OF COPPER T WITHIN PERIVESICAL INFLAMMATORY MASS

PJR January - March 2010; 20(1): 20-22

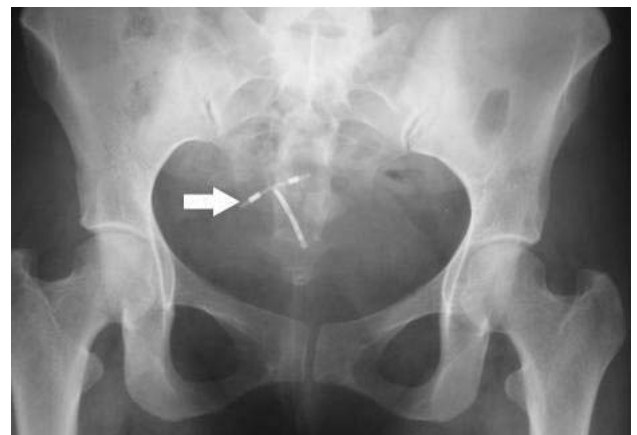
**Figure 5:** 30 year old woman with perivesical migration of Copper-T intrauterine contraceptive device. X-ray of the pelvis demonstrates a Copper-T device within the right sided hemipelvis.

A 30 year old woman (P3L3A0) presented to our institution with complaints of pain in the lower abdomen off and on for 04 months and incontinence of urine for 3 months. She had no history of vaginal discharge, haematuria, menstrual irregularity or fever. There was a history of insertion of Copper-T intrauterine device 03 years ago. The threads of copper-T were missing since 01 year. Her ultrasound revealed a solid looking hypoechoic structure in contact with and merging with right sided superolateral wall of the urinary bladder (Fig. 1). The structure measured 3.8 x 2 cm (Fig. 1-3). An echogenic linear structure was seen traversing it centrally from end to end. A sonological diagnosis of displaced copper T with inflammatory reaction in contact with right side of the superior wall of urinary bladder was given. No mass, calculus or blood clots were seen in the lumen of urinary bladder. Uterus appeared normal in size without any disruption of its walls. Fluid was seen in the cul-de-sac (Fig. 4). X-ray pelvis clearly showed a Copper T device placed slightly to the right of the midline (Fig. 5).

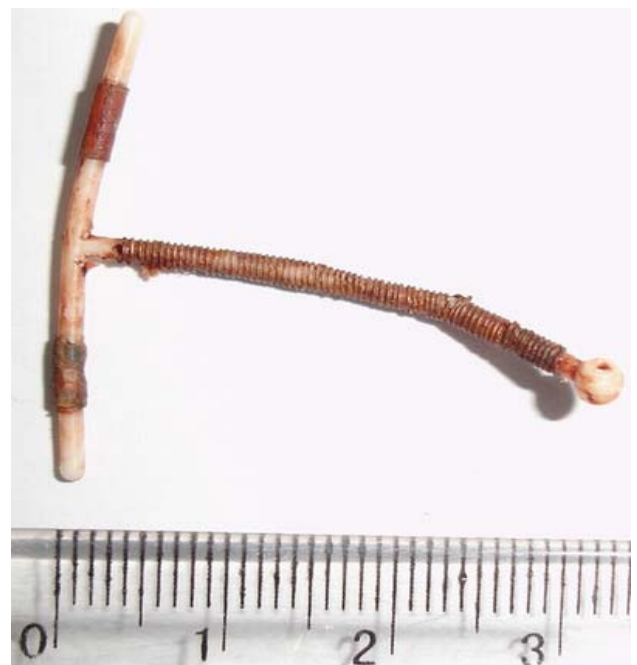
**Figure 6:** 30 year old woman with perivesical migration of Copper-T intrauterine contraceptive device: Postoperative image showing removed Copper-T.

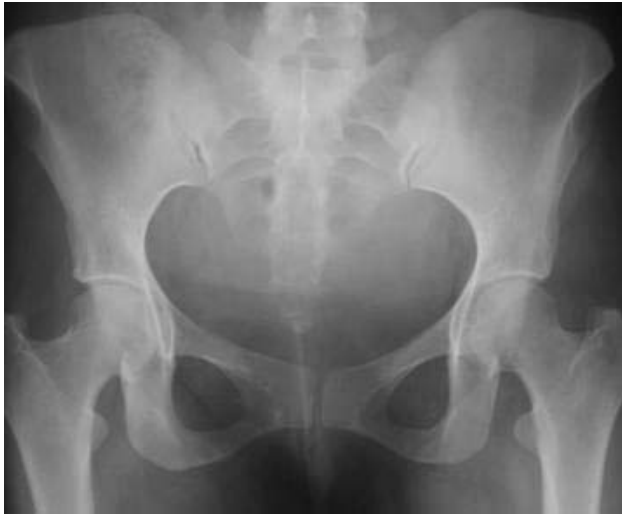
**Figure 8:** 30 year old woman with perivesical migration of Copper-T intrauterine contraceptive device. X-ray of the pelvis demonstrates removal of Copper-T device.

opened. Haematoma and abscess was removed along with Copper T and bladder was repaired with chromic. Patient was discharged on 6th post-operative day. Post operative ultrasound was done one month after surgery. It revealed normal superior wall of the urinary bladder with no evidence of hypoechoic structure. X-ray pelvis also was normal.
